MISCELLANEOUS PAPER N-71-3

DYNAMIC TESTS OF A MODEL FLEXIBLE-ARCH-TYPE PROTECTIVE SHELTER

April 1971

Conducted by U. S. Army Engineer Waterways Experiment Station, Vicksburg, Mississippi

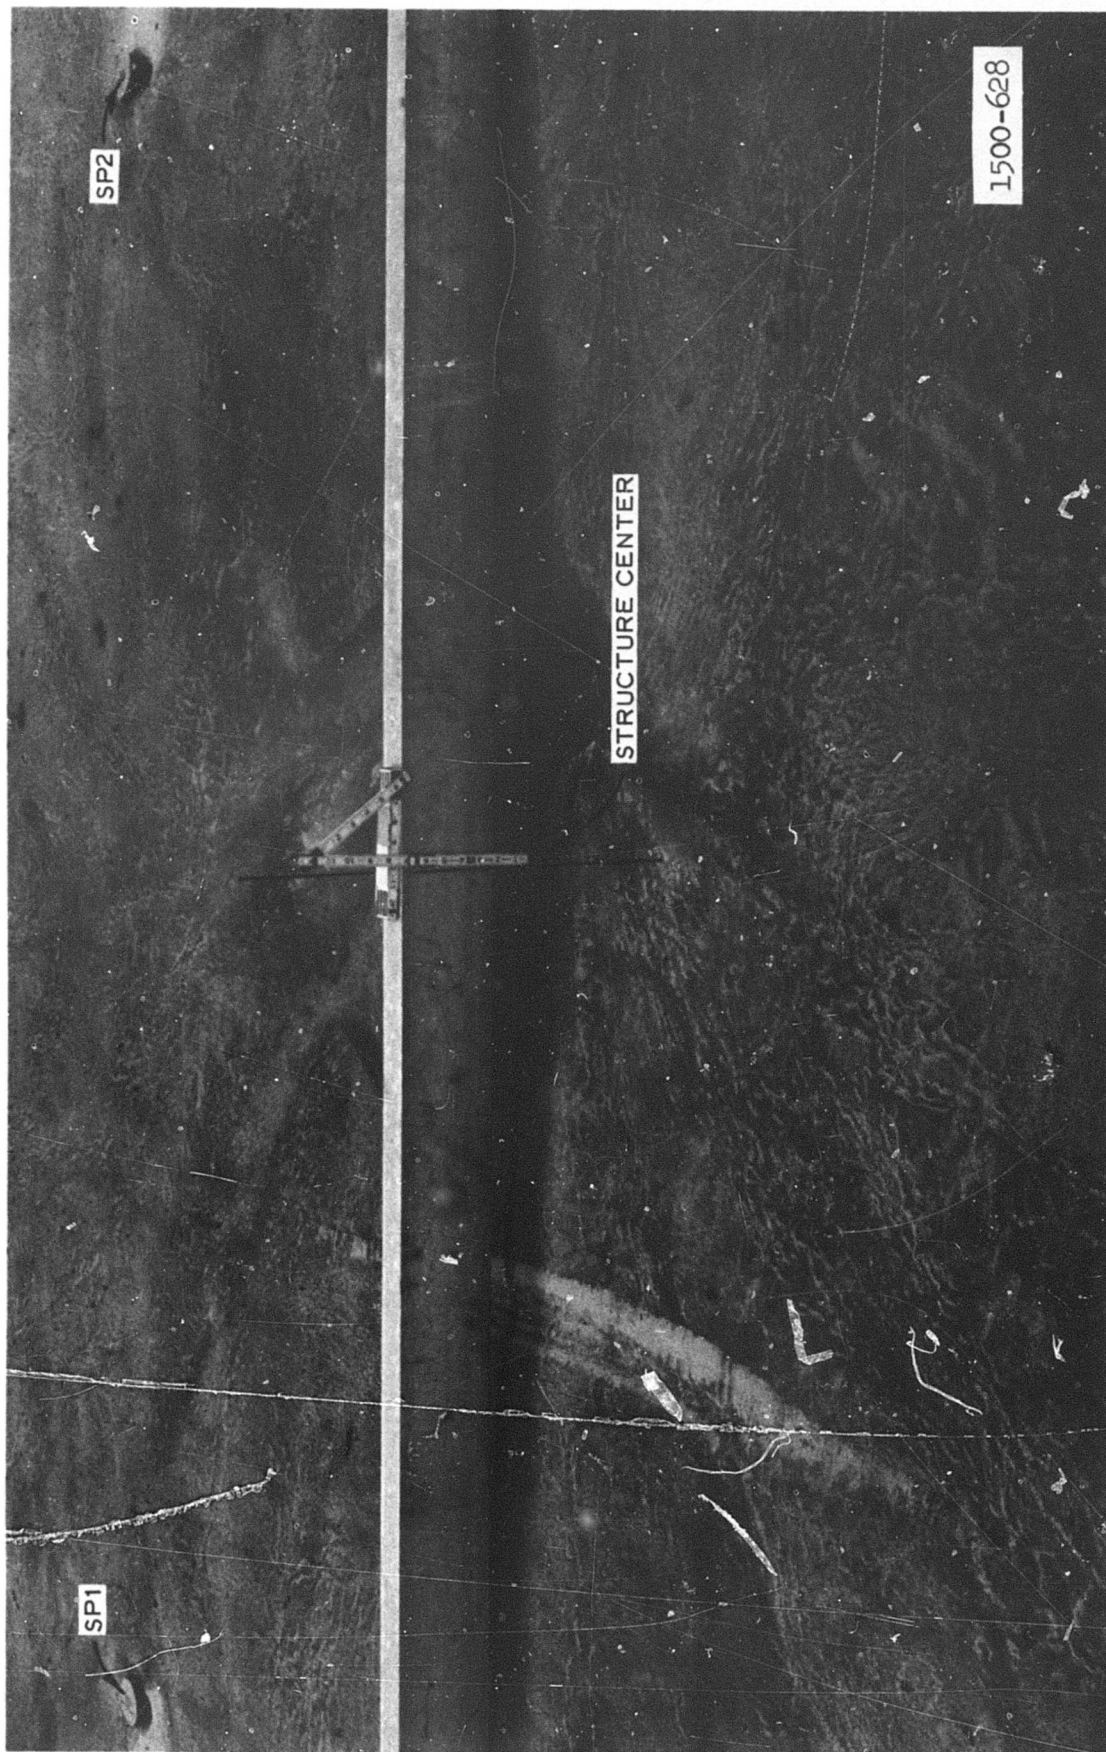
3.2.1 General Gross Motion and Damage. Shots 4 and 5 were the only tests in which the gross motion of the structure was sufficient to create a noticeable depression of the sand surface in the vicinity immediately above the structure (Figure 3.4). It became evident during excavation of the structure that the depression was caused by the vertical deformation of the steel ribs and downward deflection of the footings. While considerable displacement and deformation of the structure were noted after

Figure 3.4 Depression in the sand surface caused by the gross motion of the structure during Shot 4. Note the presence of airblast Gage SP1 in the upper left-hand corner.

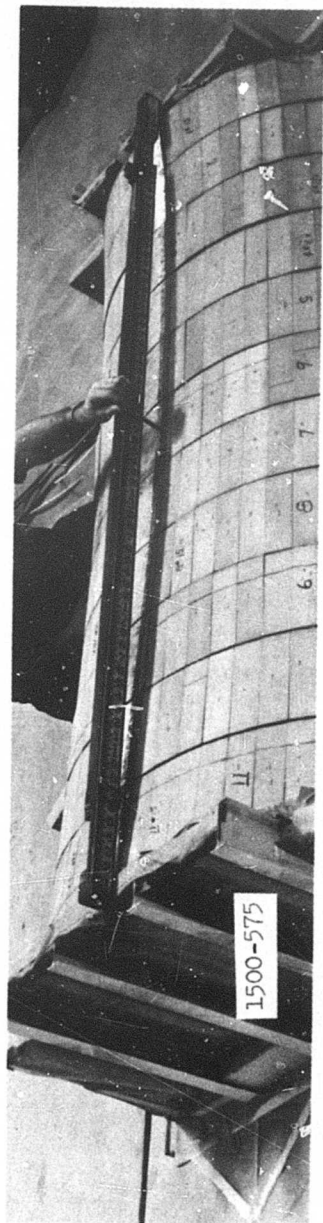
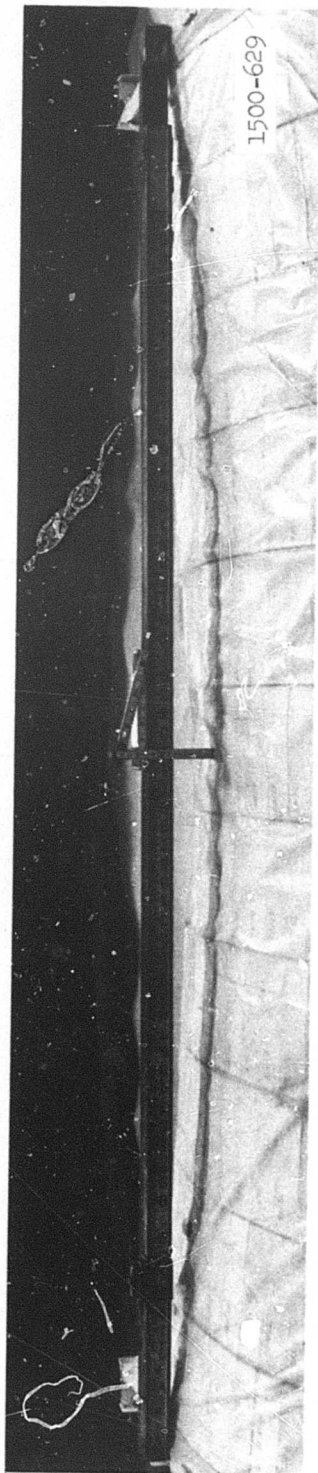
Shot 3, no definite depression was observed. Shown in Figure 3.5 is a sequence of photographs showing the structure crown curvature after Shots 3, 4, and 5.

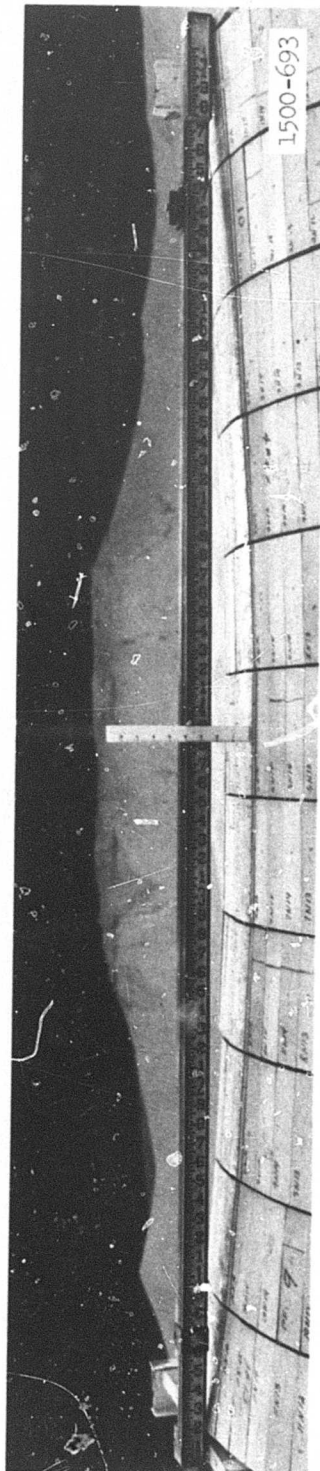
c. Postshot 5.

Figure 3.5 Postshot crown curvature.

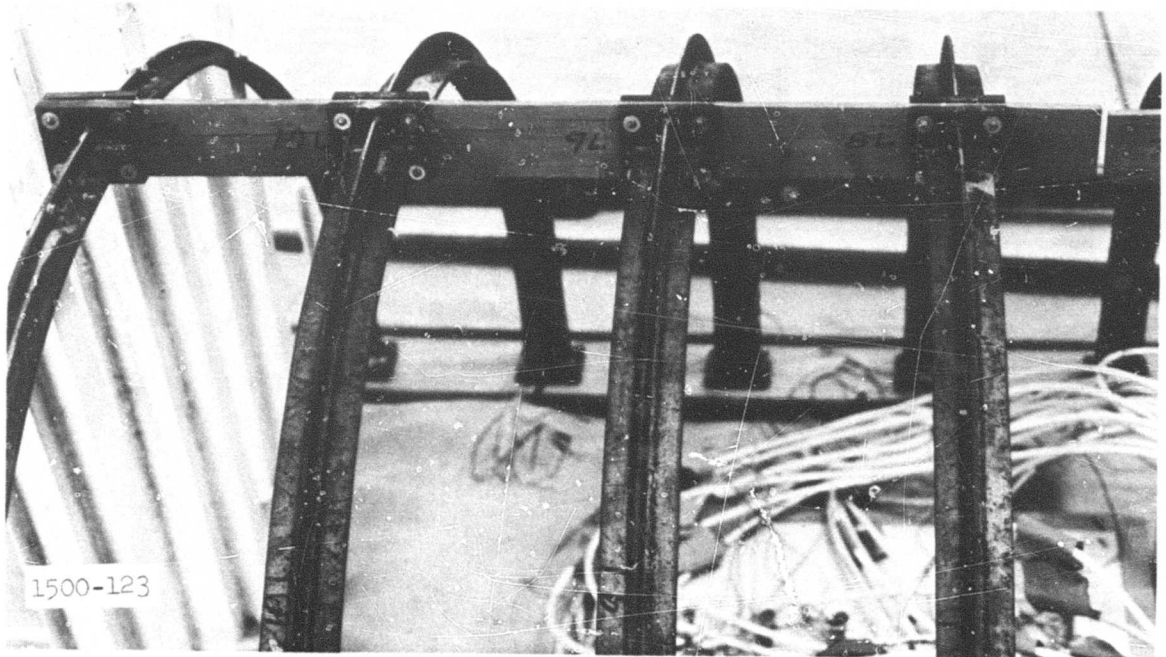
a. Pilot test.

Figure 3.6 Postshot damage to crown timber.

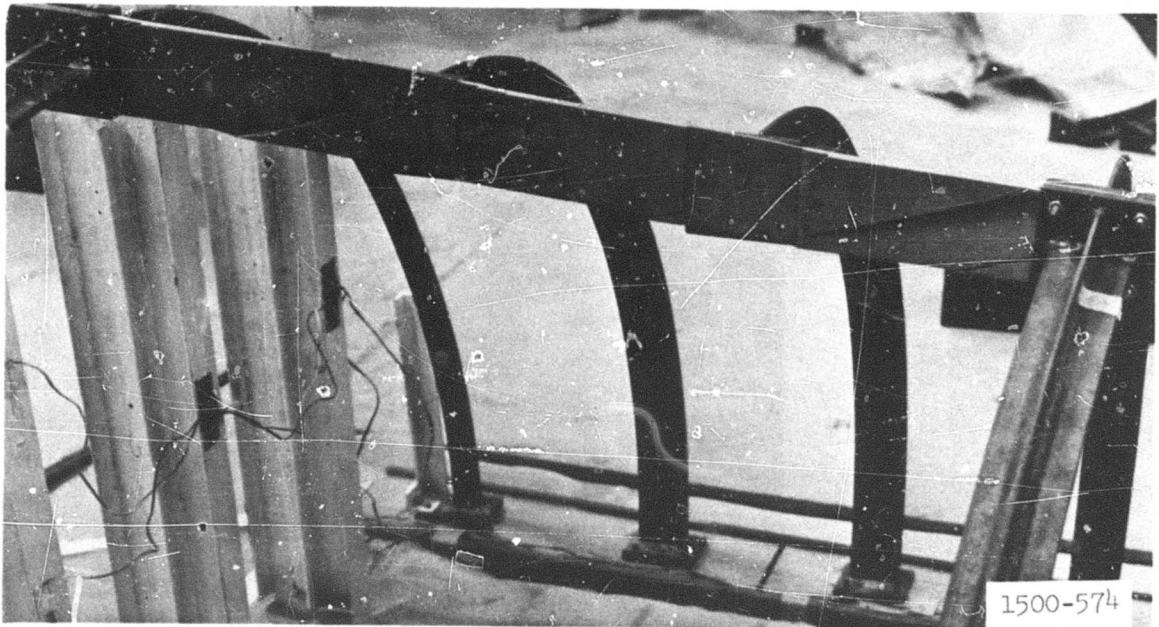
3.2.2 Component Damage. In every shot, the crown timber suffered damage. It appears to have been twisted and to have acted like a buffer absorbing some of the thrust forces. At the lower overpressures (P_{so} < 85 psi), the crown timber split slightly. However, at the higher overpressures, extensive splitting due to twist and crushing occurred (Figure 3.6). No damage was done to the timber lagging until Shot 5. During this shot the rib deformation was extensive enough to allow the lagging to bear on the footing and to take some of the thrust loading in compression. This caused some visible compressive damage to the lagging; however, the damage was slight and was structurally insignificant.

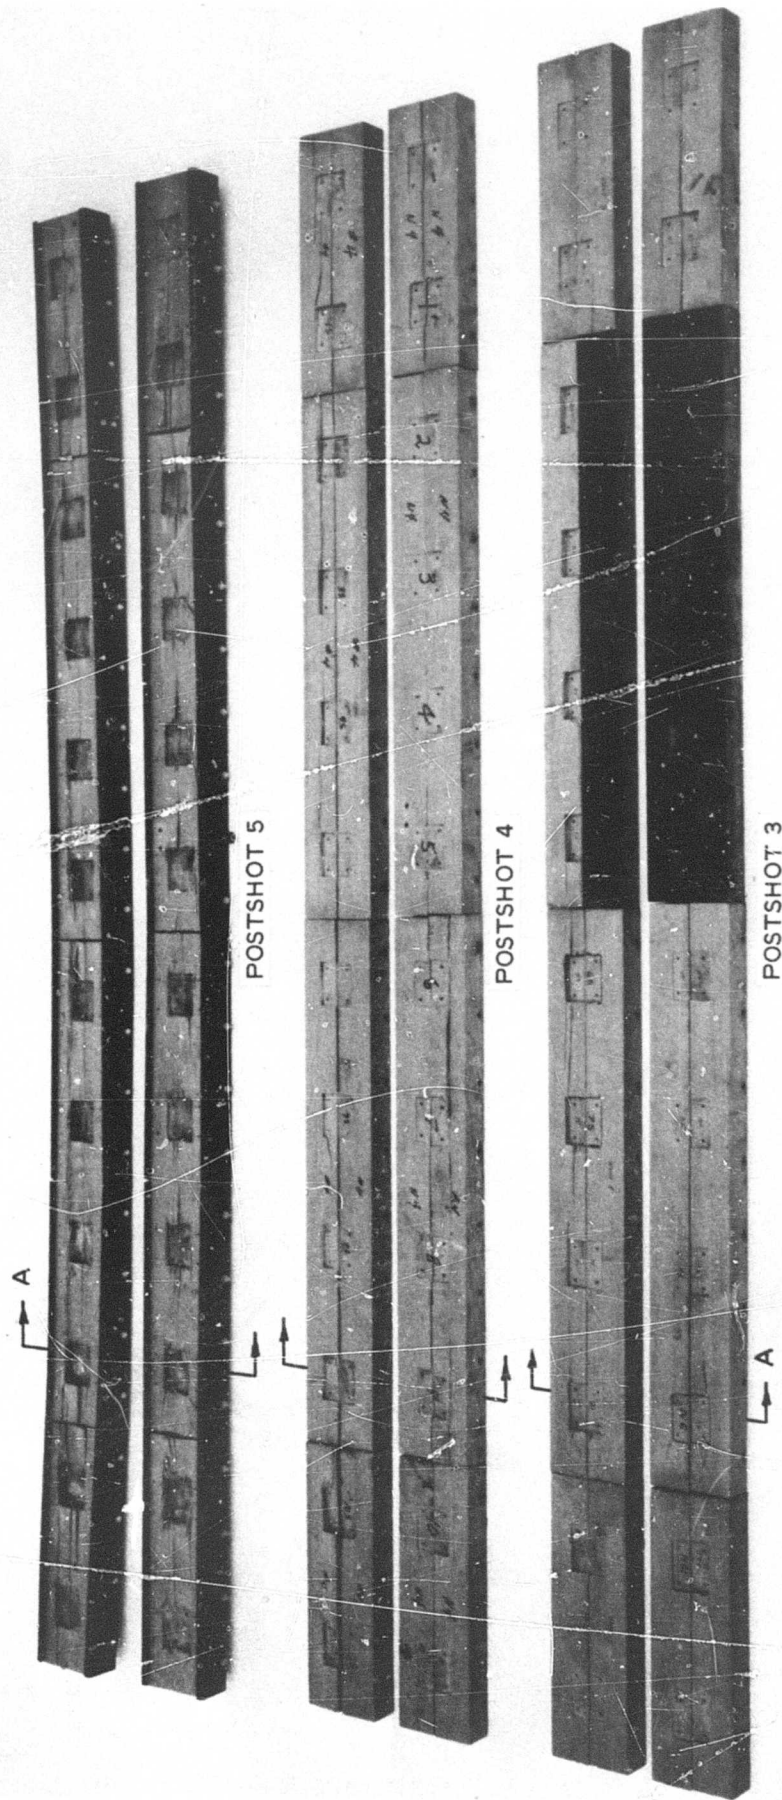
The footings were damaged extensively at the high overpressures, but were only slightly damaged at overpressures below 120 psi. They generally were bent inward and downward in the central region after each shot. This inward deformation can be seen in Figure 3.7 which shows the damage to the three sets of footings from Shots 3 to 5. Parts of the footings for Shot 3 were misplaced and are shown as black dummy sections in the figure. Generally, the damage was greater with increasing overpressure as can be clearly seen in Figure 3.8, a photograph of a section cut through the footing below Rib 9. Also shown in this figure is the deformation of the footing caused by the timber lagging as it was forced into the supporting footing during Shot 5.

Figure 3.7 Postshot view of the damaged footings showing the punching damage. Note also the inward bow of the Shot 5 footings.

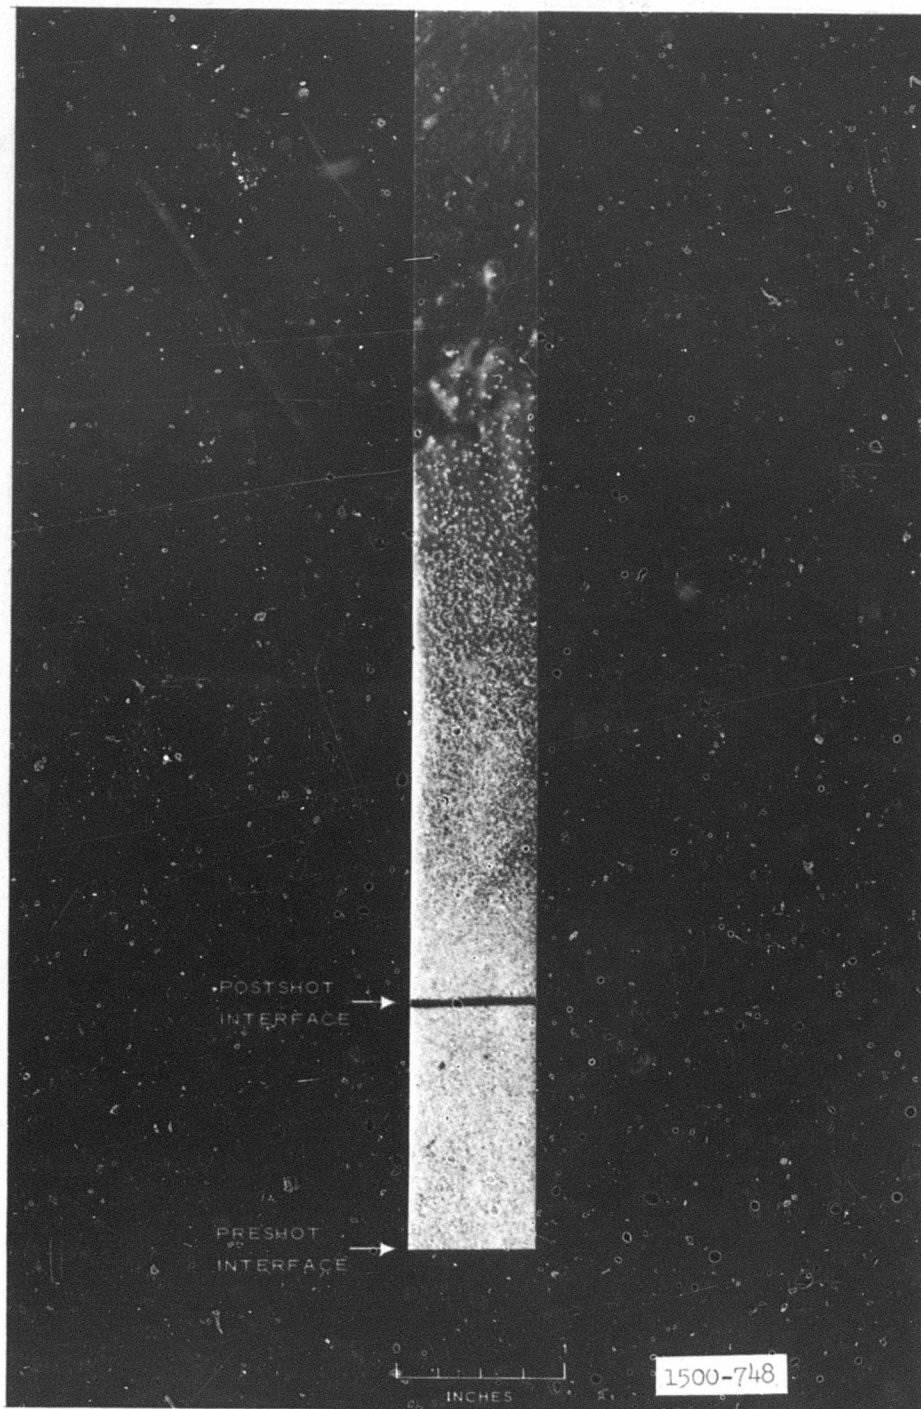
Some attempt was made to determine if a significant amount of spalling and motion of the sand floor occurred during Shots 4 and 5. In these shots a tape strip was placed vertically at about the center of the east side of the structure floor to try to measure the extent the sand surface moved upward. Figure 3.9 shows the sand distribution obtained. This record indicates that the interior floor moved up about 1.45 inches and the sand particles were thrown to a height of about 5.40 inches above the original floor level. The tape for Shot 5 did not yield favorable results. However, the interior floor accelerometer, 51VA, was thrown up and displaced from its preshot location below a sandbag (Figure 3.10). This

Figure 3.9 Sand spall of the interior floor surface
during Shot 4.

Limited spalling tests indicate that dust inhalation could be a problem in the prototype, and some means of dust prevention such as oiling the interior floor should be considered.

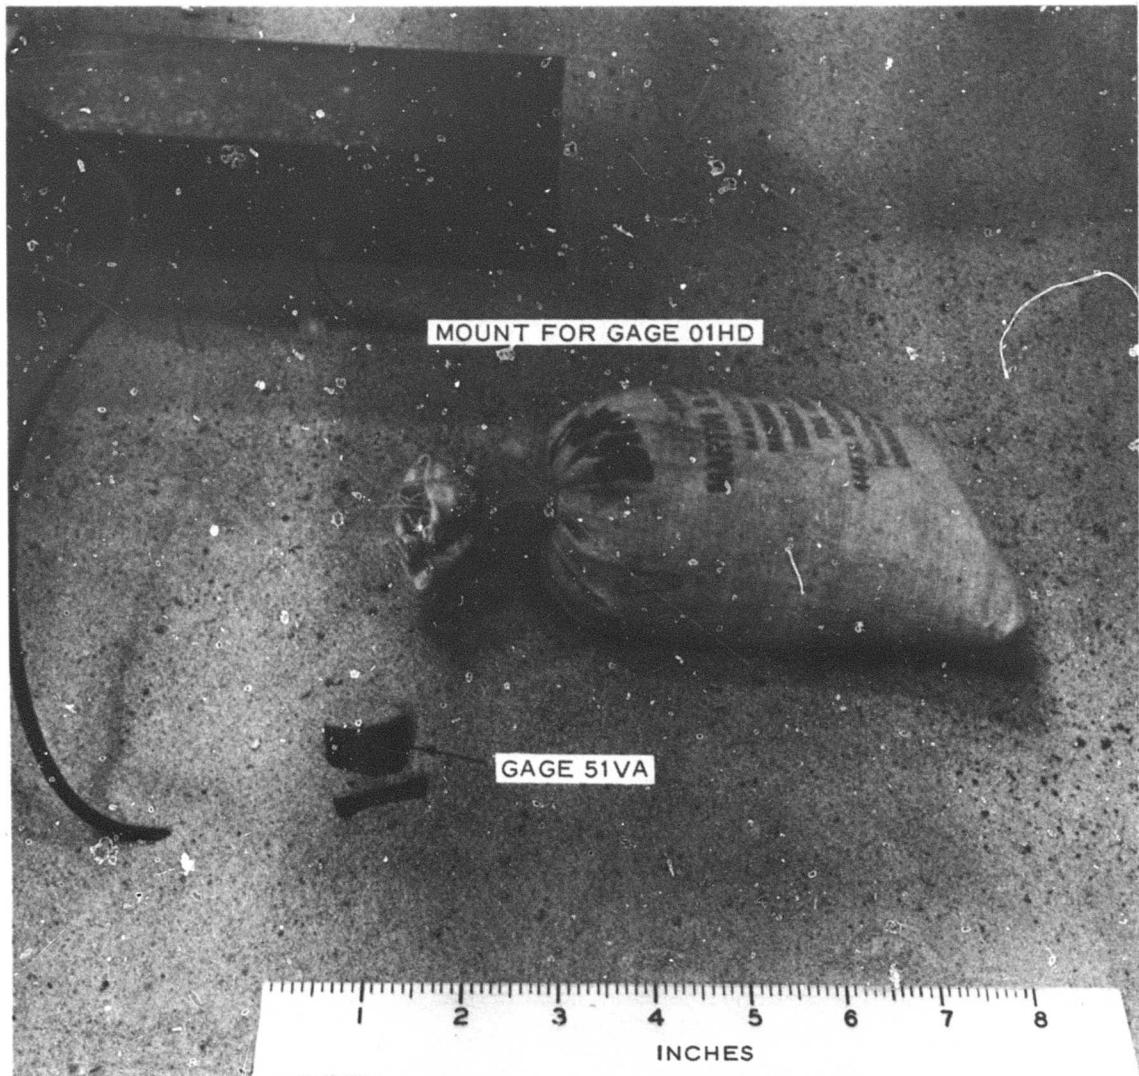
Figure 3.10 Dislocation of Gage 51VA caused by spalling of the in-
terior floor during Shot 5.

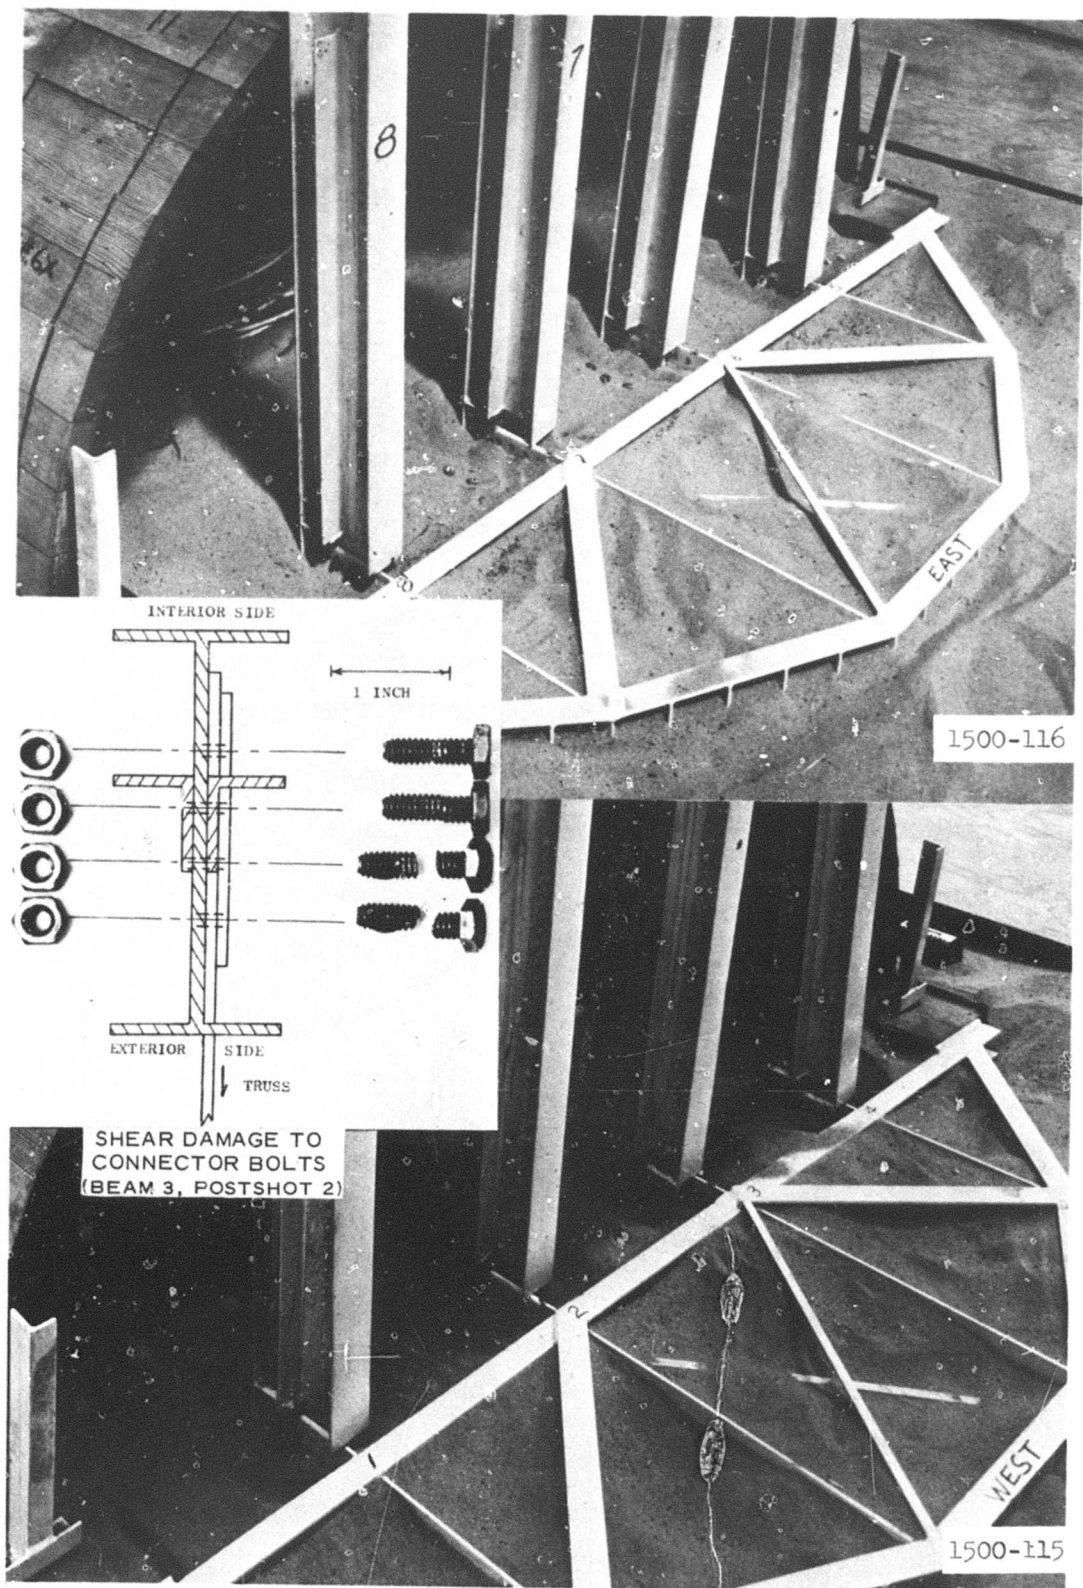
The only serious damage at low overpressure occurred at the connecting bolts between the bulkhead beams and the end trusses. Damage was first noticed here during the pilot test (Figure 3.11), and was initially attributed to insufficient bolt area causing high shearing stresses to occur. Consequently, the bolt sizes for future shots were increased slightly to provide additional shear area. During Shots 1 and 2, the same damage occurred (see inset, Figure 3.11). After closer examination, it was decided that the end truss extending out into the free field acted like a paddle, tending to rotate as the structure moved downward. This rotation occurred about the inner bolt and sheared the bolts off starting with the outer one as shown in the inset of Figure 3.11. A redesign of the connection was made using a pin connector which allows rotation. The redesign used the original shear area of the four bolts as the area of the pin and is detailed in Appendix D. Testing was continued using the modified connectors during Shots 3, 4, and 5. During Shot 3, excessive rotation caused cracks to appear in the tongue between the bulkhead beams and the end truss (Figure 3.12a). Possibly, this distress was due to fatigue since this component had been tested three times previously at lower overpressures. Prior to Shot 4, the end truss tongues were replaced and rotation cracks appeared. Again the tongues were replaced and during Shot 5 complete failure occurred (Figure 3.12b). The fact that complete failure did not occur during Shot 4 seems to indicate that the Shot 3 distress was due in part to fatigue.

SHEAR DAMAGE TO
CONNECTOR BOLTS
(BEAM 3, POSTSHOT 2)

Figure 3.11   Shear damage to connector bolts, main photographs showing the
post-pilot-test damage.

Based on the laboratory findings, it is recommended that the bulkhead truss connection be redesigned as outlined in Appendix D. This redesign will eliminate problems occurring as a result of truss rotation. With regard to the truss itself, it is recommended that a cheaper configuration be designed. It is possible to use a pair of the arch ribs laid flat and connected to the bulkhead column bases by rods.

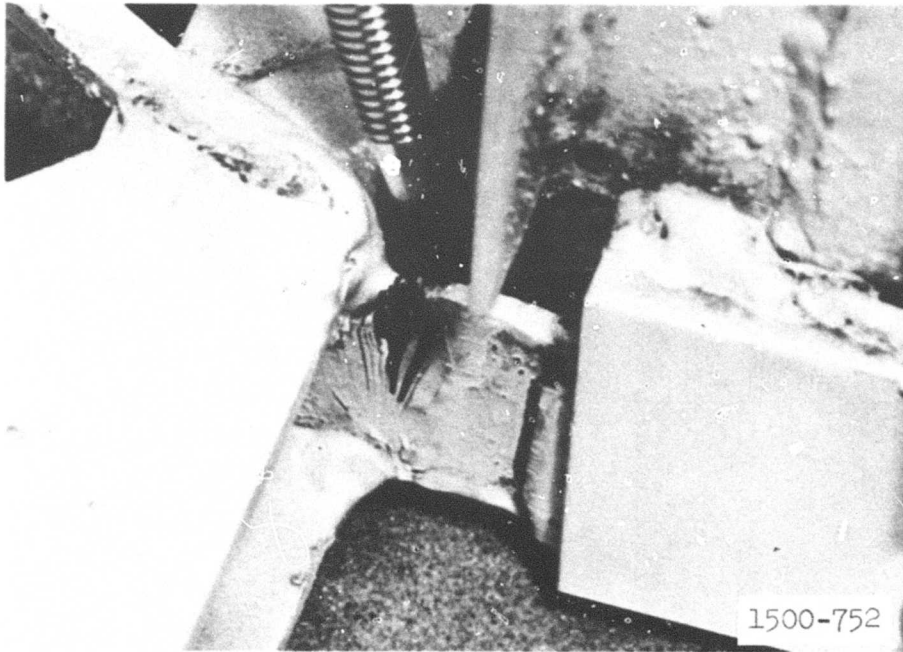
a. Postshot 3. Shear damage to the Beam 2 connector tongue.

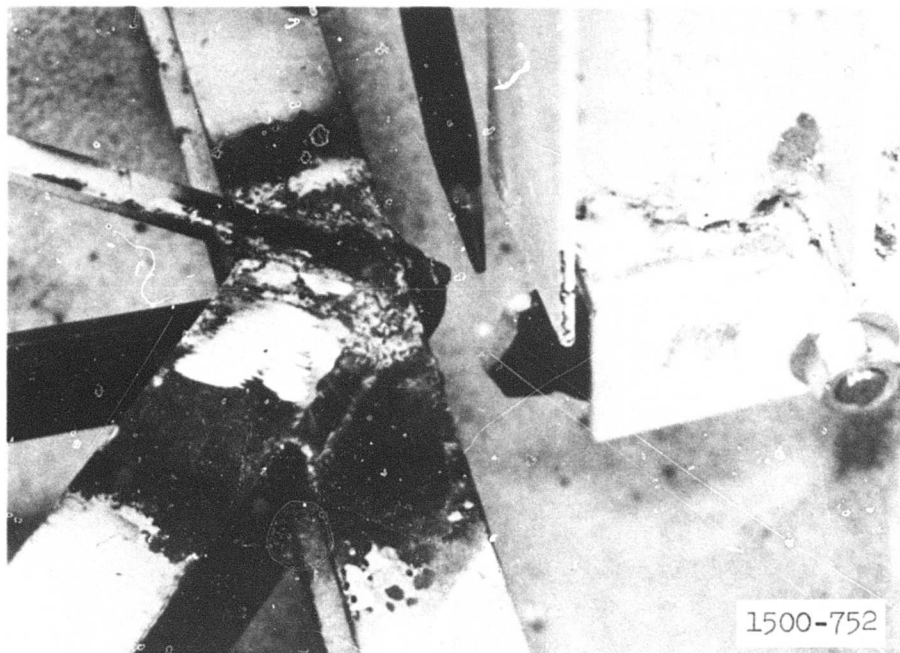
b. Postshot 5. Shear damage to the Beam 2 connector tongue.

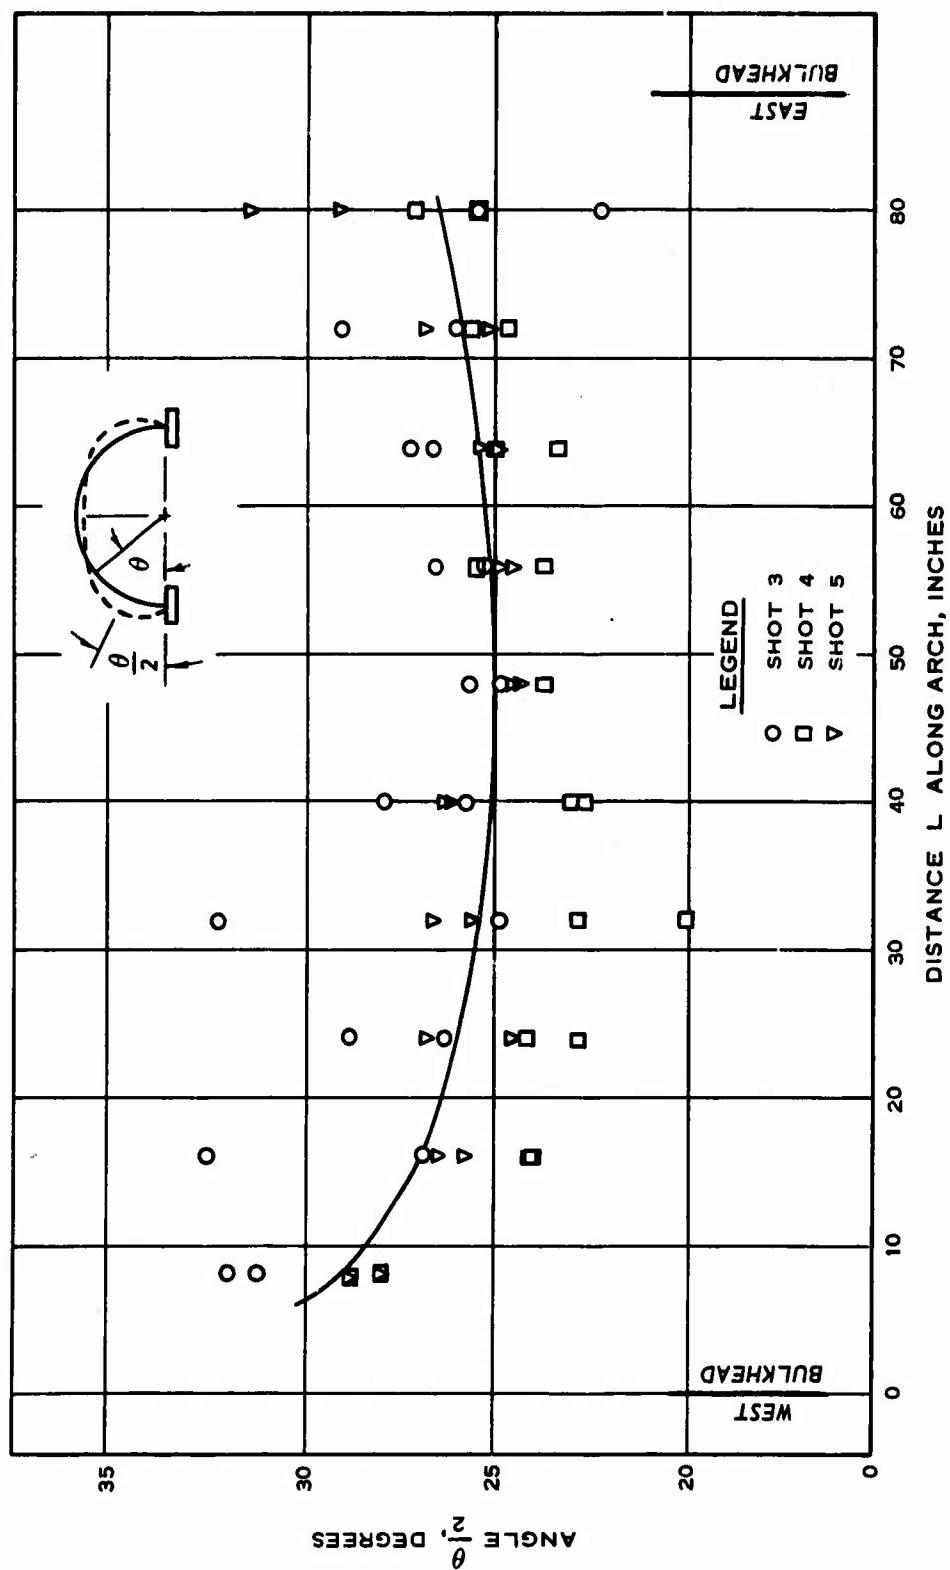
Figure 4.4 Permanent deformation of Rib 6 after Shots 3, 4, and 5.

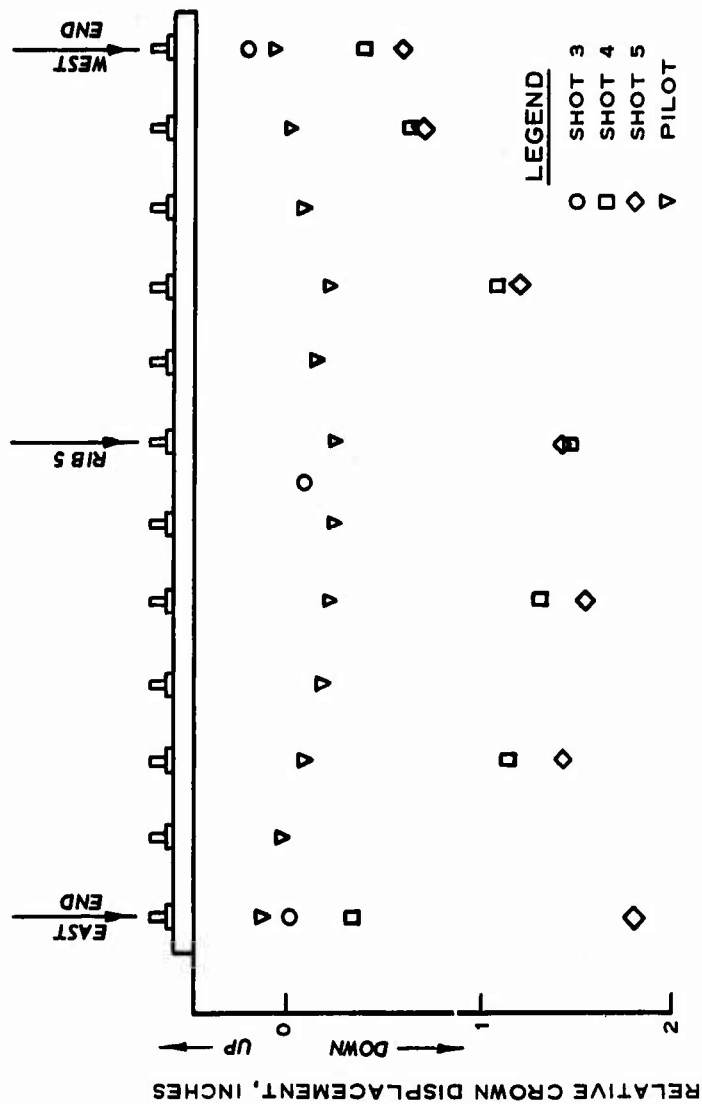
In Figure 4.6 the surveyed crown deflection relative to the footing deflection is shown with the average of the north and south footing deflections at a location being assumed as the footing deflection. Both the footing and the crown deflection data show more scatter at the west end, especially in the case of Shot 4. This is thought to be due to the

presence of the free-field instrumentation cables which generally were run out the west end of the structure to the free-field gages. The difference in relative crown deflection between Shots 4 and 5, and between Shot 3 and the pilot test indicates that there was little rib deformation at the lower pressure with most of the motion being rigid-body motion, whereas at the higher pressures rib deformation became a major factor in total crown deflection. The rib strain data as well as the data in Figures 4.4 and 4.5 support this supposition.

Figure 4.6 Level survey, postshot crown deflection with respect to the footings.

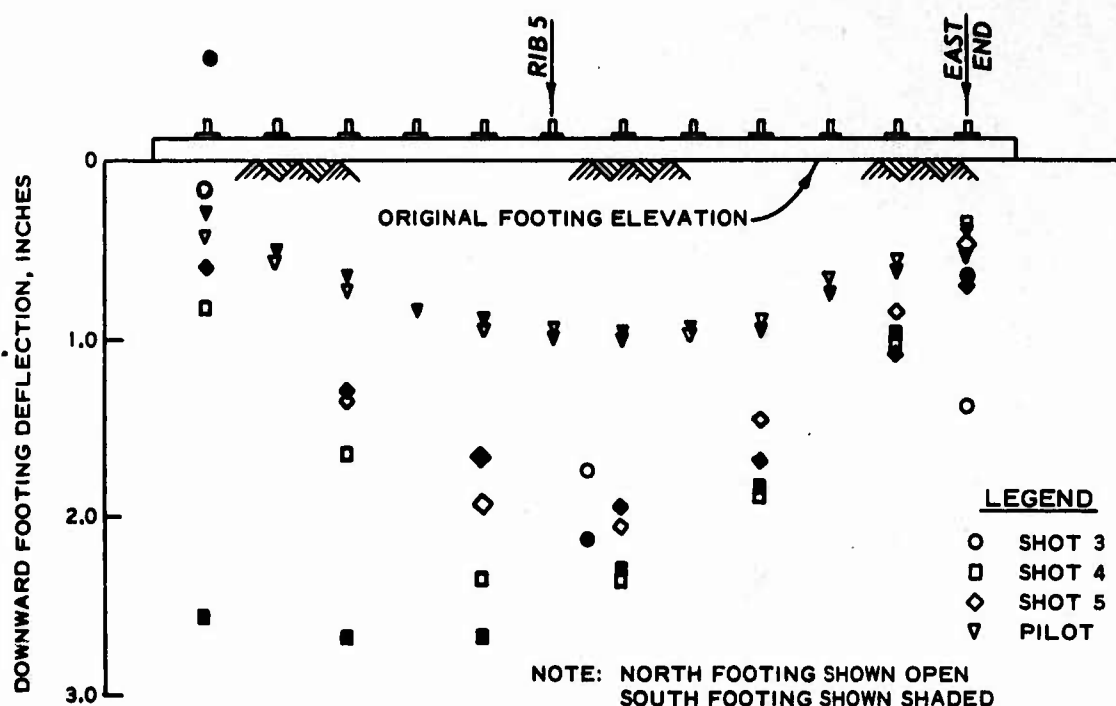
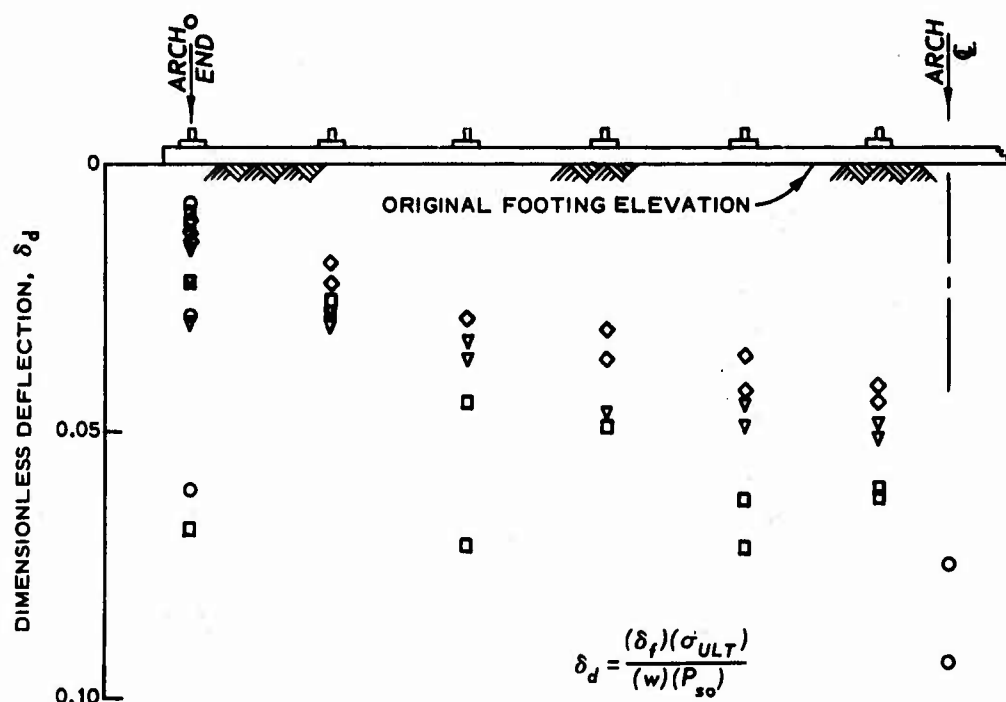
The measured time-deflection histories of the footings near the vertical centerline of the structure for Shots 3, 4, and 5 are shown in Figures 4.8, 4.9, and 4.10, respectively. These data were calculated using the deflection gage data from the rig shown in Figure A.4. The deflection components are shown in Appendix C. These data show that there was an initial displacement radially outward corresponding to the arrival of the loading at the crown region of the structure. This was followed by a downward deflection as engulfment occurred during which time the outward motion reversed to become an inward displacement. Final downward displacement occurred in a jerky fashion because of the arrival of the reflected stress wave. The final position of the footing as measured agrees with those data in Figure 4.7 and agrees with observed final shape of the footings as shown in Figure 3.7, i.e. bowed inward.

Figure 4.7   Level survey data for footings.

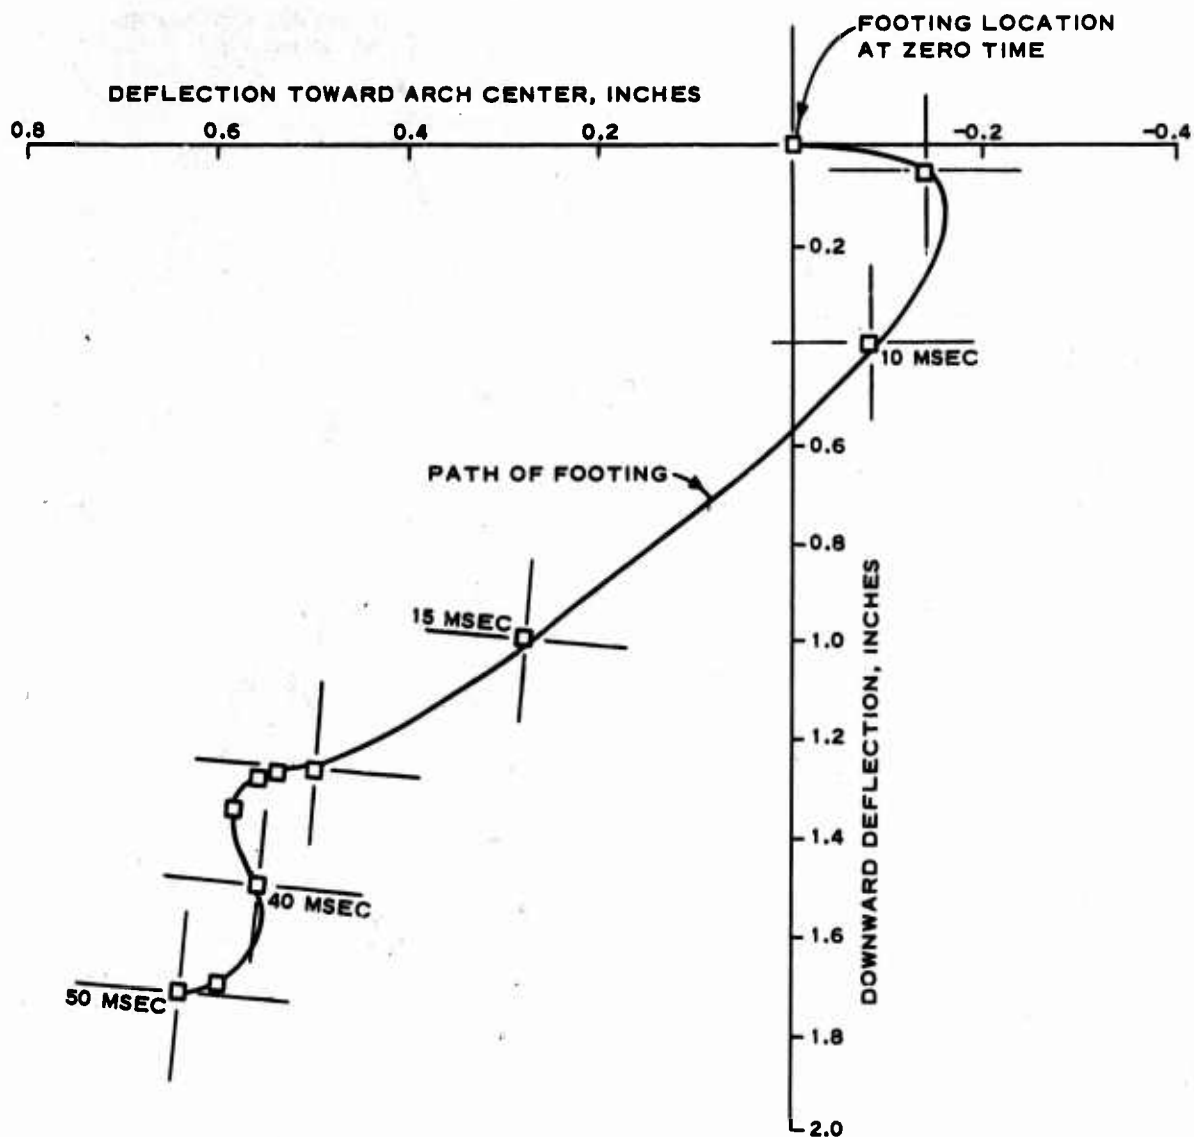
Figure 4.8 Footing motion of the north footing center during Shot 3.

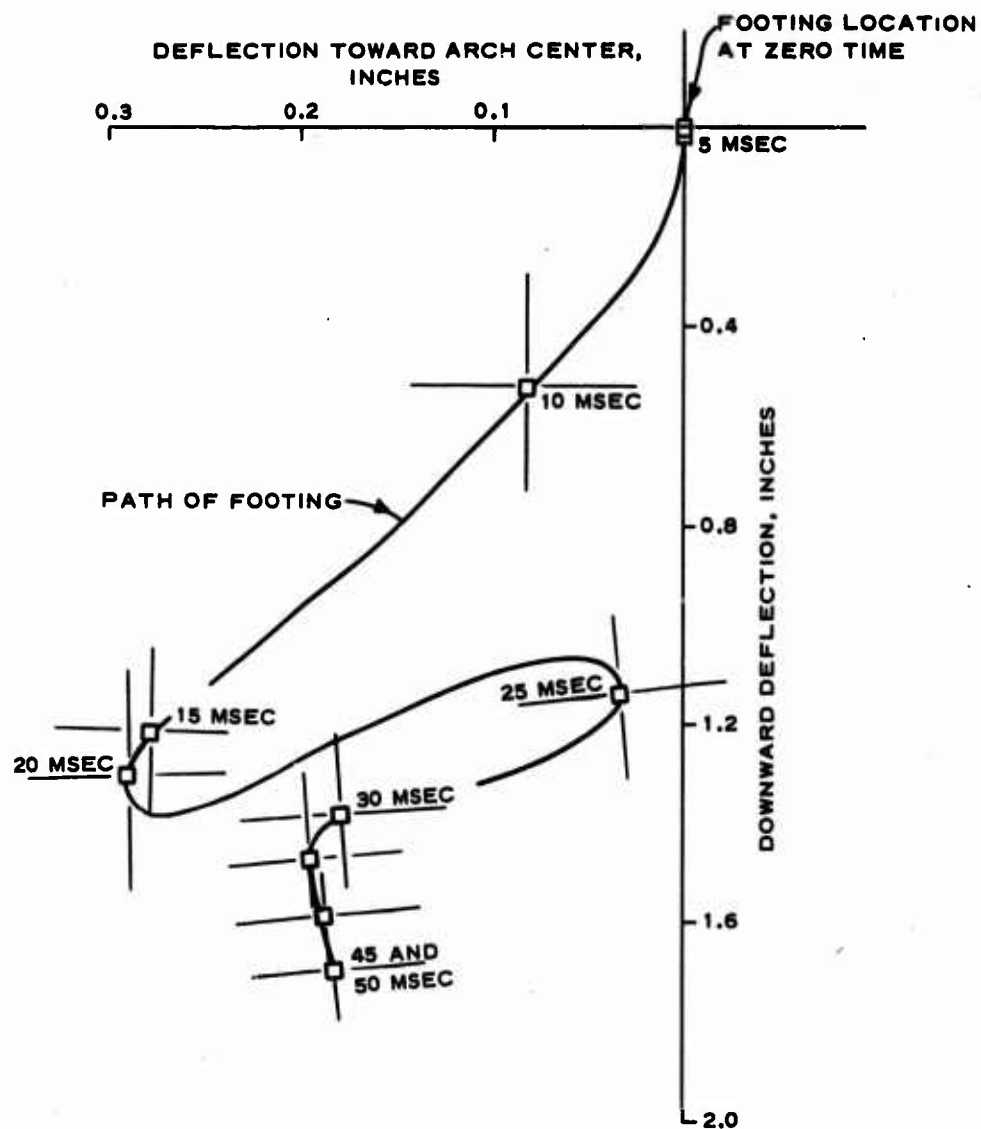
Figure 4.9 Footing motion of the north footing center during Shot 4.

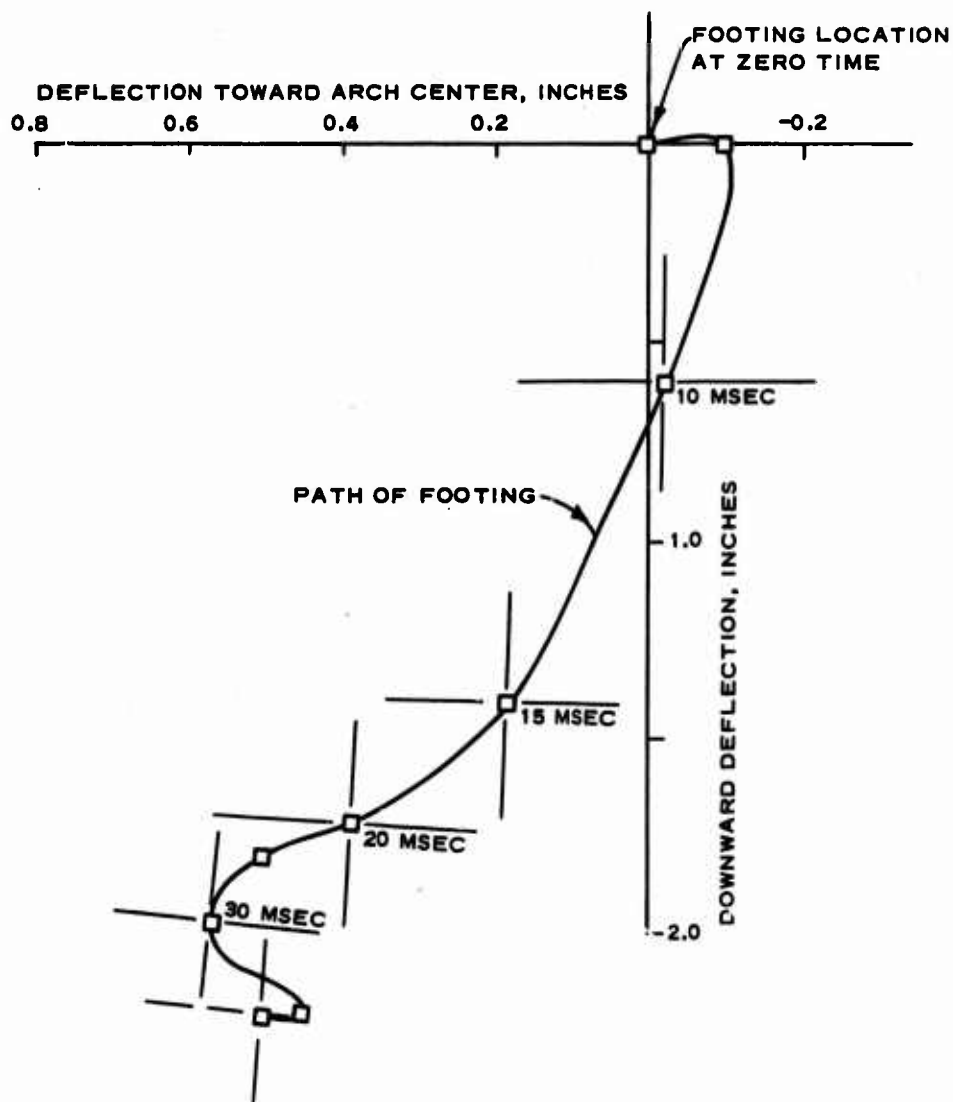
Figure 4.10 Footing motion of the north footing center during Shot 5.

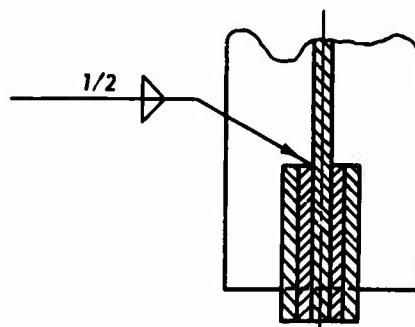
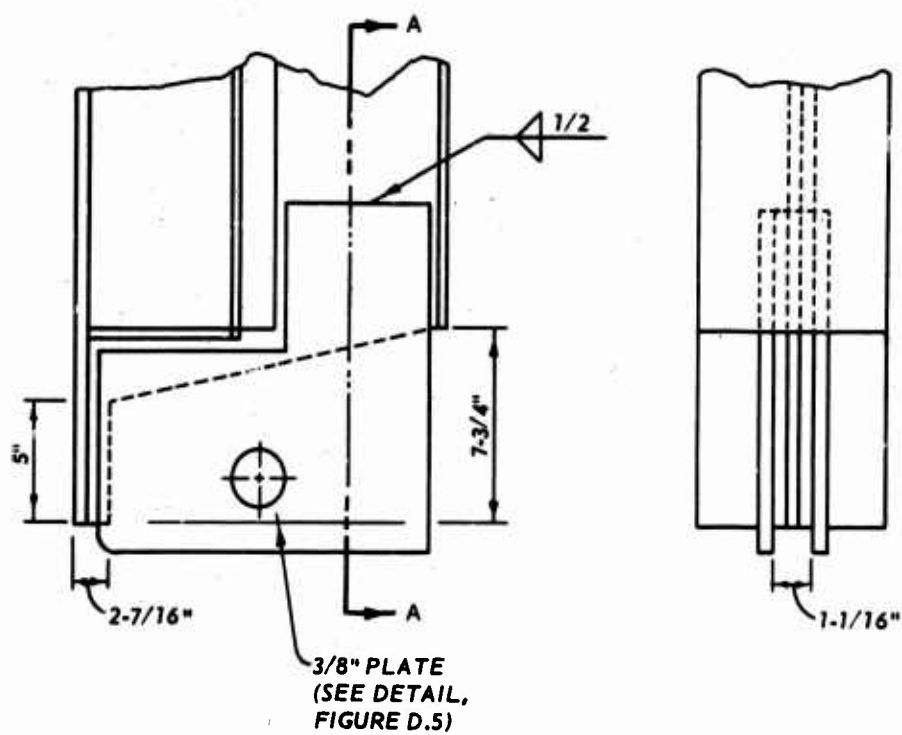
As discussed in Section 3.2.2, difficulties were encountered at the connection between the bulkhead columns and the end truss. These problems arose because of the rotation of the end truss about the connecting bolts which was caused by the gross motion of the structure. To alleviate this problem it was necessary to redesign the connectors to allow for this rotation. This redesign was done between Shots 2 and 3 and was in use during Shot 3. The new connection was designed as a pinned joint. This appendix details the redesign procedures and the redesign, and uses all of the original assumptions made in Reference 1.

Figure D.2 Detail of the modifications made to the structure column-truss connection.
